## Corrosion Performance Survey of Cars Manufactured in India

In the summer of 2015, the IIT Bombay conducted a study to evaluate the corrosion performance of automotive body panels in the challenging climatic environments of India's more than 7,000 km long coastline.

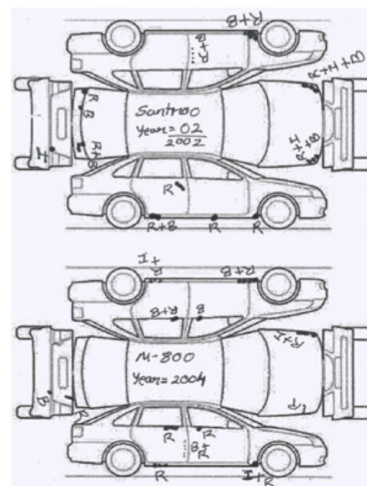
Two surveyor teams each consisting of two people examined the cars for corrosion failures on the engine hood, trunk deck, rocker (sill) panel, and door panels around the handles. Schematic diagrams of cars featuring these four panel areas were given to the teams to mark the imperfections on the part. Imperfections with a minimum of 1x1 cm or a group of imperfections corresponding to that size were considered. The teams inspected 30-40 cars per day and recorded also the car model and brand as indicated on the car; and the year of manufacture based on the last two digits of the Vehicle Identification Number (VIN) which is visible through the windshield on all Indian vehicles.
