Technical Note 3.07 Transit Abrasion on Galvanized Sheet Steel

Indian Sheet Steel Building Group: Technical Note 3.07 Transit Abrasion (Fretting Corrosion) on Galvanized Sheet Steel

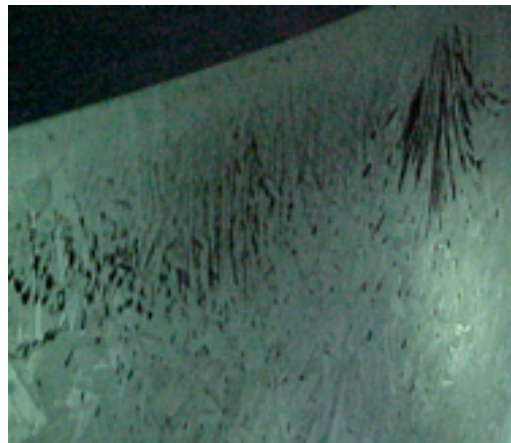
Figure 1. Fretting near coil edge

Figures 1 and 2 illustrate the appearance of fretting on galvanized surfaces. In this case the marks are near the edge of the sheet and were reported to have mirror images on the opposite surface.⁷ Figure 2 is a close-up of the mark on the right hand side of Figure 1.⁸

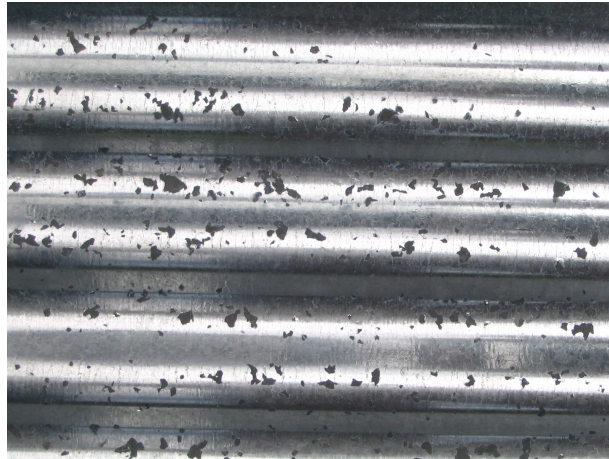
Figure 5 is fretting on corrugated galvanized sheet that was observed after transport to a jobsite from a roll-forming mill.⁹

Figure 5. Transit Abrasion (fretting) on corrugated galvanized sheet

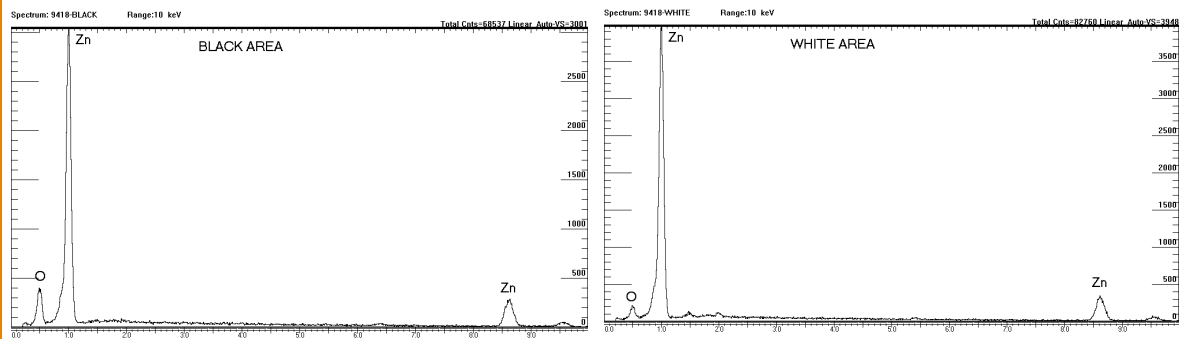
Figure 6. Analysis indicating black area has at least twice the oxygen content of the normal white zinc. (Courtesy of Shantanu Chakraborty/Rajib Chatterjee – TATA Steel India)

O	Al	Si	Fe	Zn
Black	14.74	1.17	0.63	1.55	81.92
White	6.97	2.25	0.68	0.88	89.22
