Performance of Prepainted Sheet Steel with Different Polymer Top Coats in Roofing & Cladding Applications

Kenneth M. de Souza
International Zinc Association

Abstract

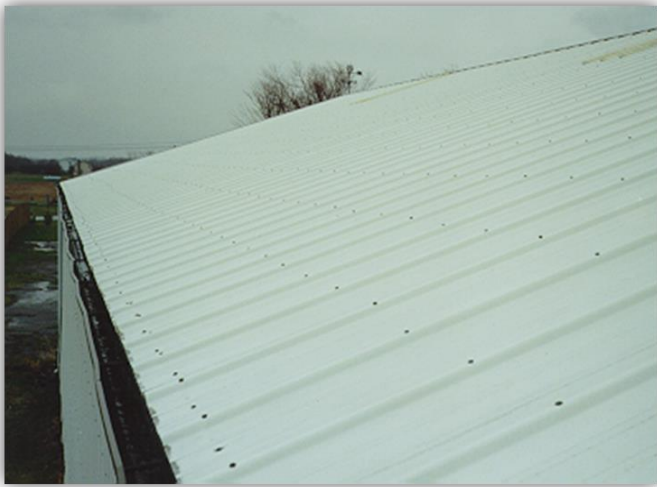
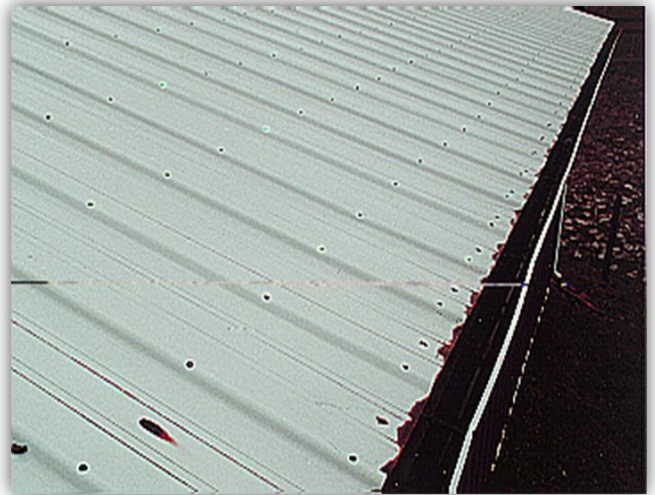
Photograph 1: Drip Edge Condition

Prepainted Galvalume - 16 years

Prepainted Galvanized - 14 years

Photographs 1 – 4 show the performance of the roofing panels after being in service for up to 16 years. One can clearly see the significant amount of red rusting at the drip edge and at the major and minor tension bends.

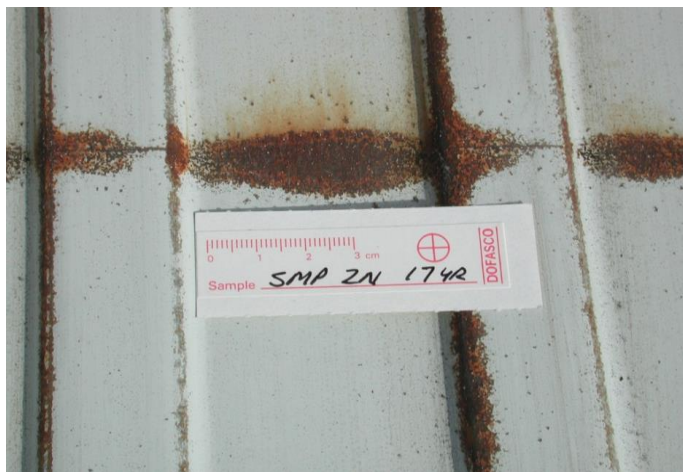
Photograph 2: Southern Ontario – SMP

Galvanize – 17 years

Galvalume – 17 years

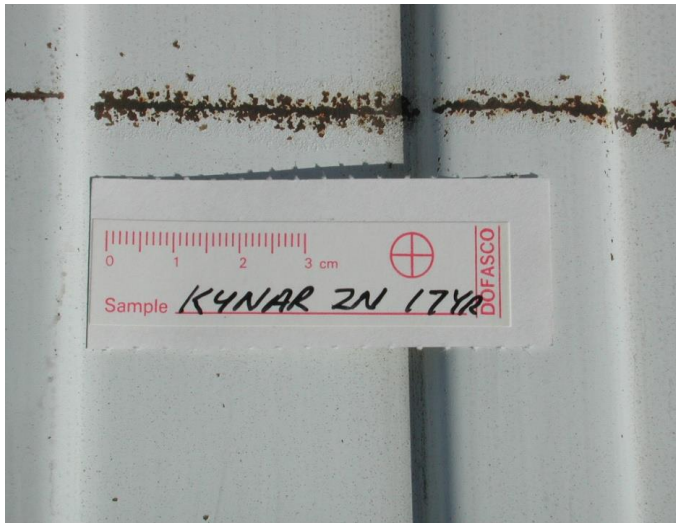
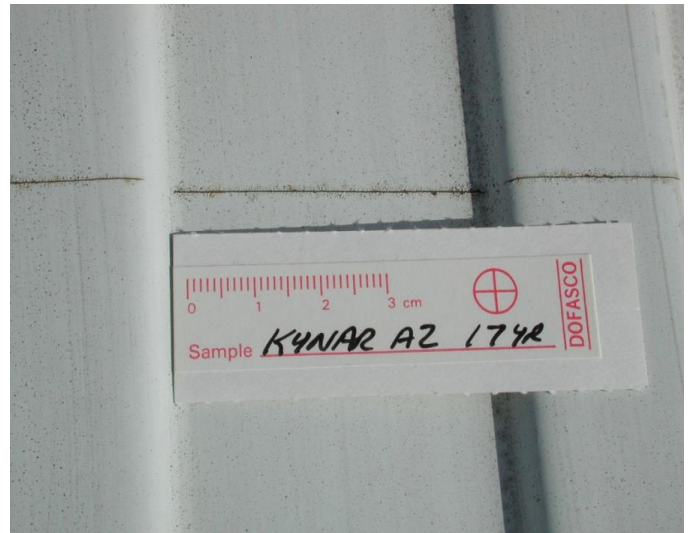
Photograph 3: Southern Ontario – PVDF

Galvanize – 17 years

Galvalume – 17 years

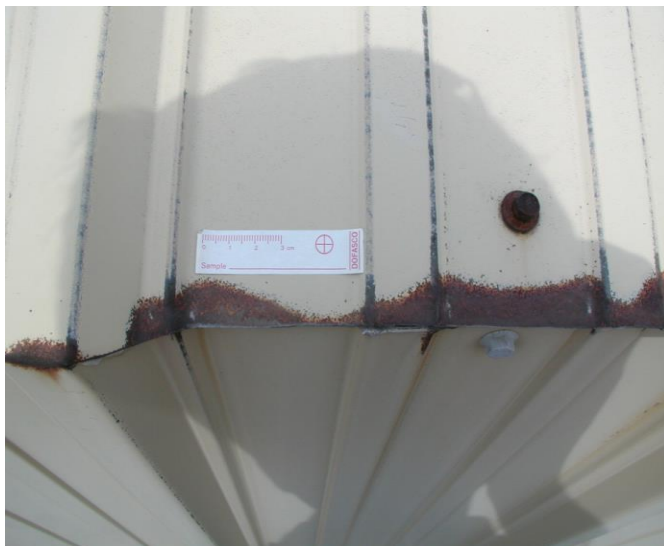
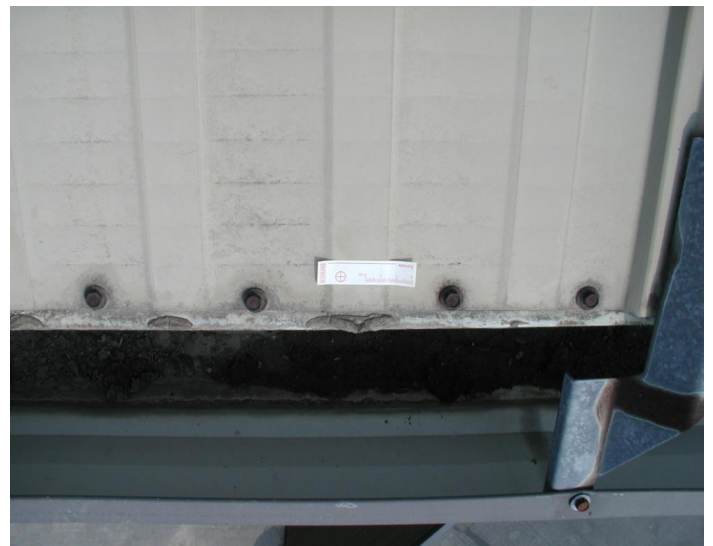
Photograph 4: South Eastern Ontario SMP

Galvanize (steep slope) – 20 years

Galvalume (low slope) – 20 years

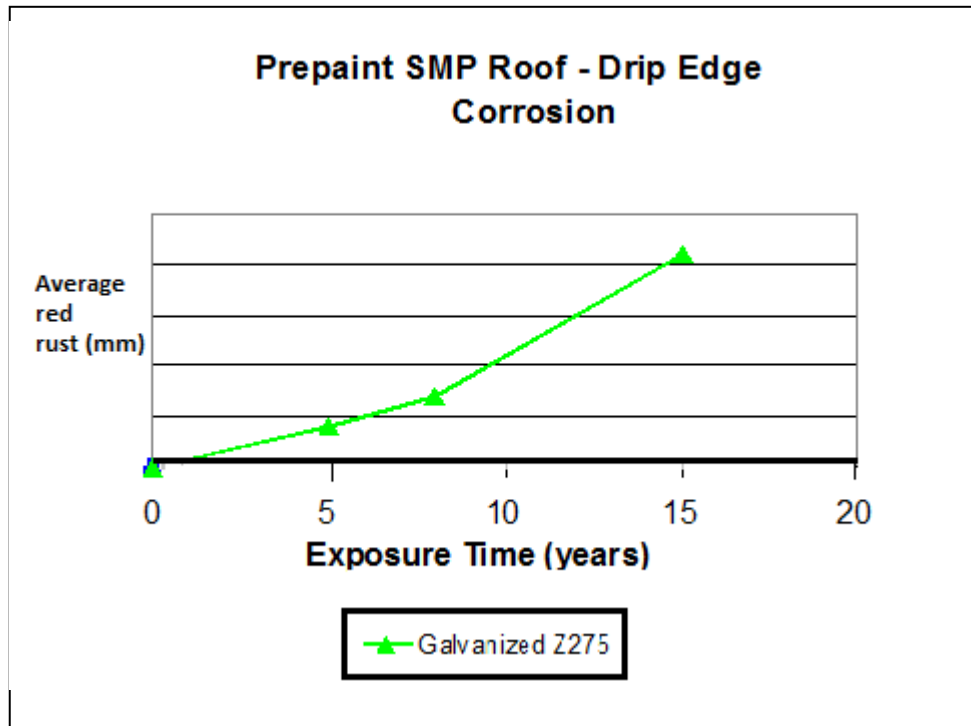
Figure 1 shows the roof drip edge data for SMP preainted galvanized buildings. The roof drip edge is generally regarded as the worst case condition on a building and is used as the benchmark against which the Prohesion test data is compared. Obviously, the walls typically experience less corrosion because of their vertical orientation but can be expected to show the same performance behaviour as the roofs, given sufficient time. Note that the average red rust measured at the roof drip edge for SMP preainted galvanized is over 20 millimeters after 15 years.

Building Inspections - Acid Rain Environment

Finally, Figure 5 is a plot of performance of SMP pre-painted galvanized and Galvalume after 400 and 800 hours in the Prohesion Test. One can see the similarities in the performance trends between the Prohesion test and the building inspections shown earlier in Figure 1. Note also that while the amount of red rust at the drip edge is considerably lower in the Prohesion test, the ranking of the materials, the failure mode, and the diverging performance between the substrates follows that seen in actual building inspections.
