Hot Dip Galvanizing in Mining

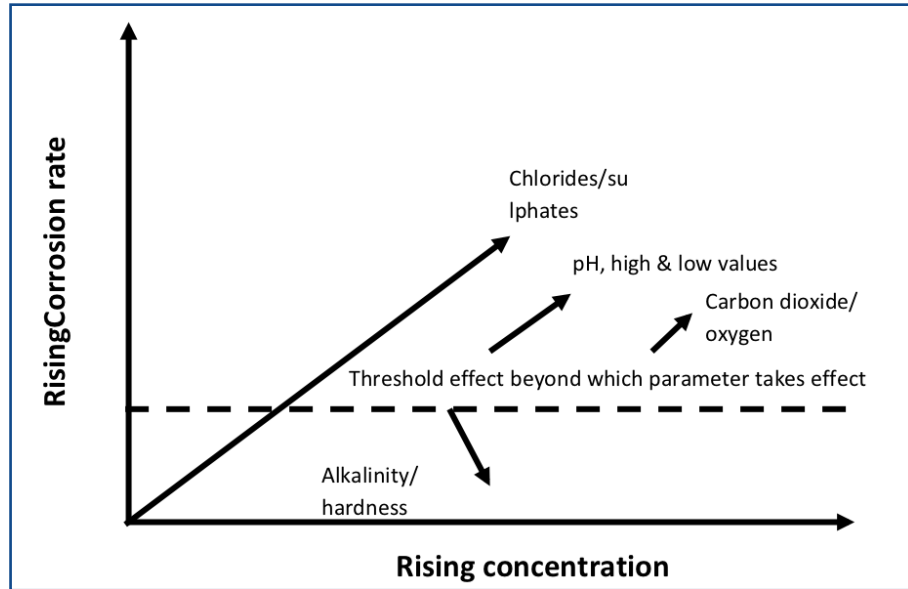
Figure 2. Effects of water quality on corrosion rate of HDG

In addition, water contains numerous dissolved salts. In mine waters, dissolved carbon dioxide and oxygen can also be found. The effects of all of these impurities on corrosion rate are summarized in Figure 2.

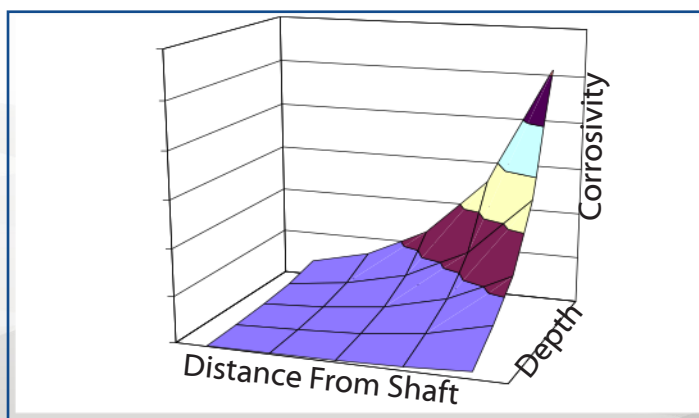
Figure 3. Corrosivity underground rises with increasing depth and distance from shaft

With increasing depth and distance from the shaft towards the working area, the corrosion severity and incidence of mechanical damage increases substantially. Underground workings are often wet and the waters tend to be corrosive due to pickup of fumes (such as blasting fumes) and ingress of acidic waters into the working areas. Shaft areas can become aggressive to steelwork due to water, falling objects and dust, resulting in the formation of poultrices, which allow corrosion to continue under the poultrice.

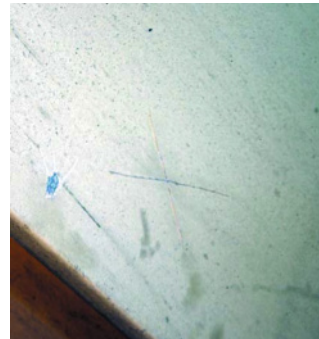
Cross cutting proved that adhesion of the coating was sound.

After 10 years, an inspection showed the duplex coating to be in exceptional condition, such that the organic coating had to be purposefully damaged in order to assess the adhesion of the organic coating and the overall condition of the hot dip galvanized coating underneath.

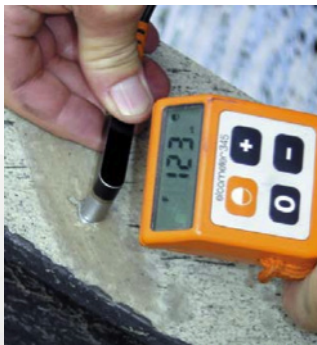
Hot dip galvanized coating thickness (paint removed)

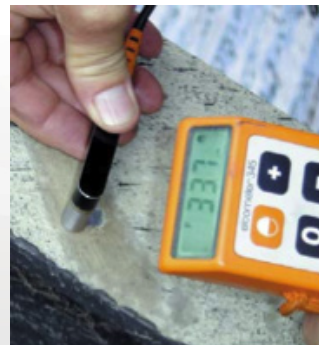
Total duplex coating thickness

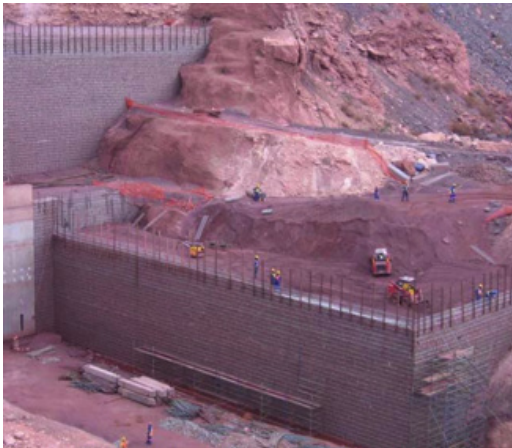
Wall B of crusher nearing completion

Mechanically reinforced walls were required to enable access by the 400-tonne tipping trucks to the crusher. The backfill was comprised of magnetite, which had a higher density than typical quarry backfill materials and thus required additional retainment. Tests showed that this had no effect upon either the corrosion of galvanized weldmesh or reinforcing strips.

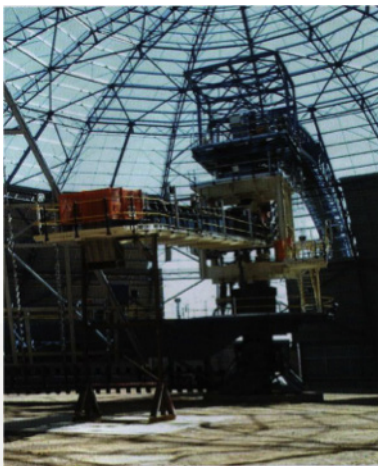
Skorpion Mine stockpile dome under construction

The remoteness of the site necessitated large sections of the stacker/reclaimer to be prefabricated and transported to site for erection, with little sub-assembly occurring on site. The largest prefabricated section was approximately 45m long, 2.5m deep and 2m wide. It was critical that the stacker/reclaimer was erected before any work on the dome began. Erection of the dome took careful planning, as the structure would only self-support once the final structural elements were in place. Consideration of the dome's erection formed a significant part of its engineering. Temporary support was required during construction. The center column of the stacker/reclaimer provided some support, reducing the need for additional support structures. Erection of the dome was without incident, due to computer-orientated steelwork detailing and trial assembly in the workshop prior to transportation to site.

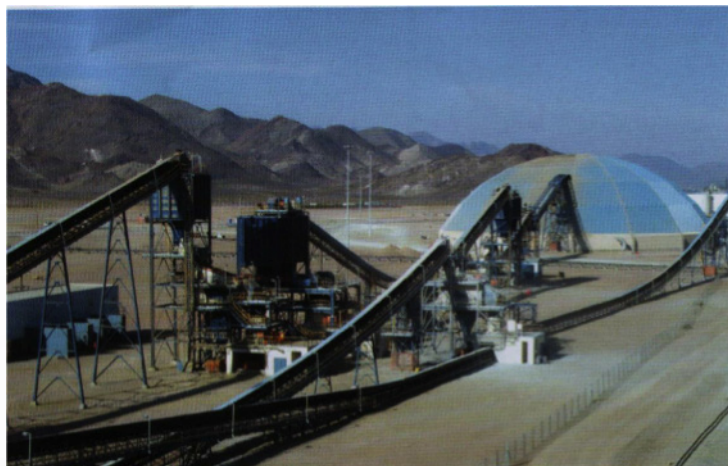
Skorpion Mine stockpile dome near completion

The Skorpion Mine is located in the Southern Namib Desert and is a large opencast operation. The circular stacker was installed to handle a 50,000 tonnes run-of-mine stockpile. Some 300 tonnes of steelwork went into the dome which was clad with 11,300m² of color coated galvanized sheeting. The dome is 93m in diameter and 30m high. There are 25 conveyors, the longest being several kilometers long. Environmental considerations were paramount, with dust being one of the main concerns. The stockpile was stored in the covered dome and all conveyors had dust control systems. Feed conveyors were covered with profile color coated galvanized sheeting.

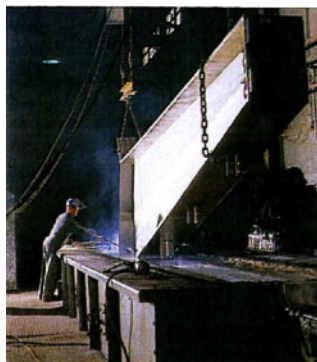
Steel support column for the concentrate storage building. Because of their size, each column required double dipping in the galvanizing kettle.

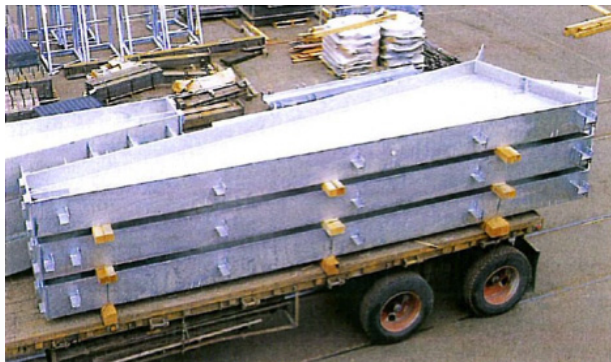
Support columns loaded onto a transport truck. A total of 100 columns each weighing about 3 600 kg were hot dip galvanized for the storage building.

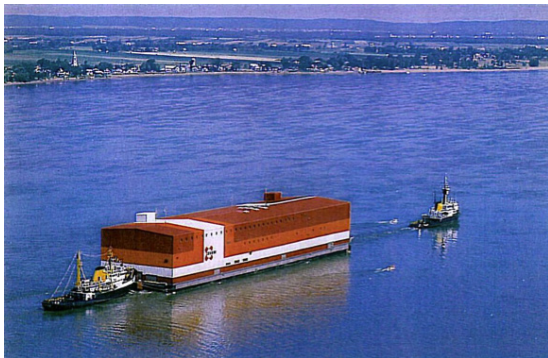
The processing plant on a barge in Trois-Rivieres, Quebec on its way to site. On-site, this plant houses the concentrator, the mine's maintenance and storage areas, workshops and four diesel generators to supply the total electricity needs of the operation.

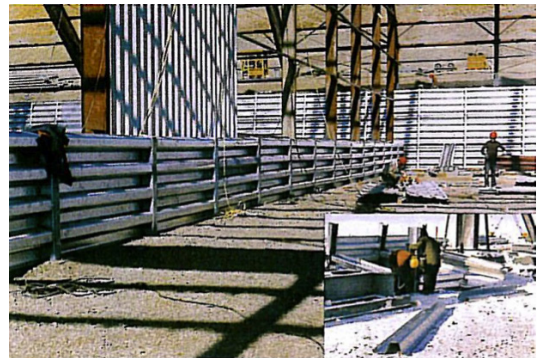
Galvanized steel retaining walls make up the base of the concentrate building. The insert shows the assembly of the crib walls.

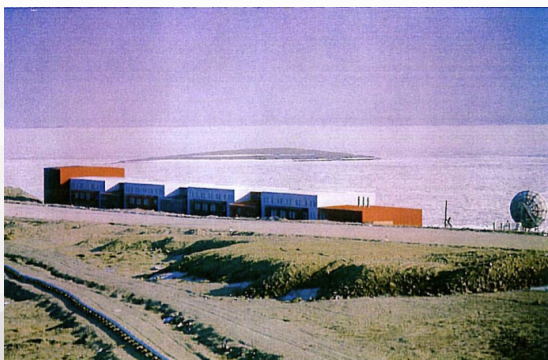
The 275m long accommodation building is a modular structure consisting of a linear arrangement of alternating two and three story units. Built under a large movable hangar, this award winning design in galvanized steel allowed work to proceed at a rapid rate even throughout the worst winter conditions.

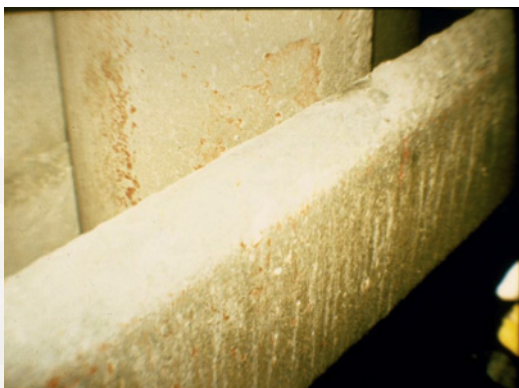
Deposits over "duplex" and hot dip galvanized shaft steelwork at Kinross

In the wet zone, the galvanized steelwork was protected with an epoxy coating. Little degradation of the duplex system was evident where full saturation was not occurring. Some blistering of the epoxy was noticed on the pipe column but the galvanized coating continued to provide excellent protection of the underlying steel. Both the zinc and paint were destroyed on the top surfaces of the buntons because of continual impacts from falling debris. The nearby galvanized station steelwork was still in good condition; this area is normally not exposed to continual saturation by water or impact damage by falling debris.

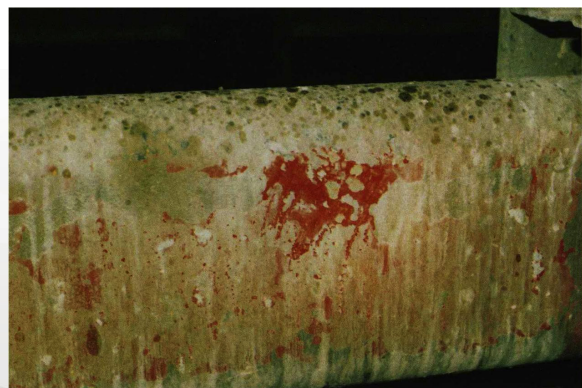
After ten years bunttons were shown to be in good condition, although, as would be expected, the top surfaces did show strain. However, no perforation was noted requiring no costly replacement.

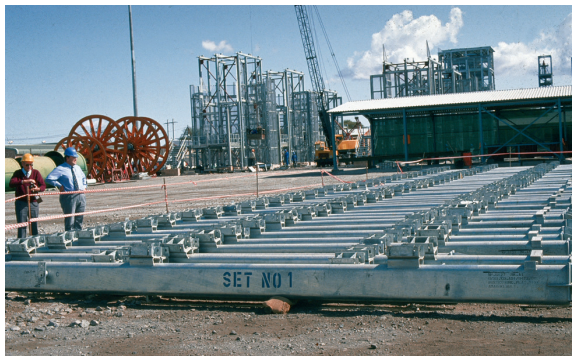
Shaft steelwork assembled above ground to ensure fit-up.

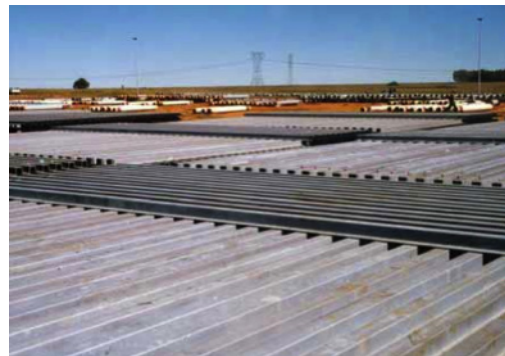
Hot dip galvanized shaft guides correctly laid out on site, awaiting installation in the shaft.

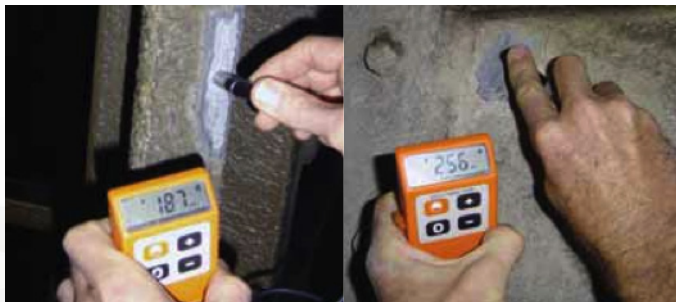
The coating thickness on shaft buntions at four different levels were inspected but as they were similar in residual coating thickness, only two have been reported. The calcareous growth in most instances was removed prior to measuring the residual coating thickness.

A follow-up inspection was carried out in 2006, during which the coating thickness was found to be 150 to 300 μ m. At some areas of mechanical damage, the coating had chipped; however, measurement showed that a coating thickness of 25 to 35 μ m was still present (mainly an iron zinc alloy layer). No under-film creep or other evidence of steel attack was observed, despite this damage; the galvanized coating was still protective.

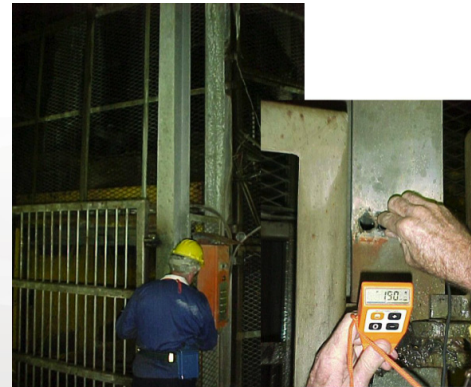
Coating thickness of shaft station steelwork

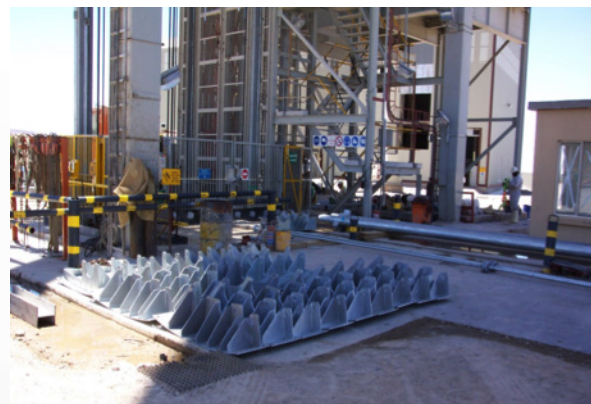
Galvanized steel structural components

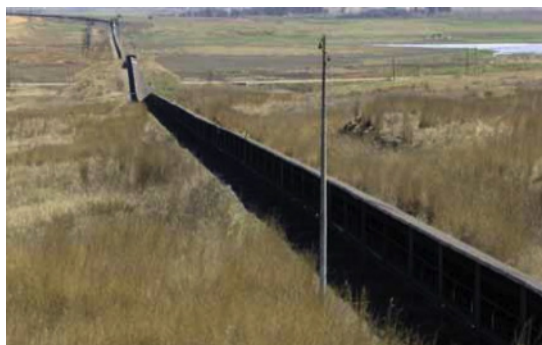
The V3 overland conveyor has been exposed to the elements for in excess of 20 years.

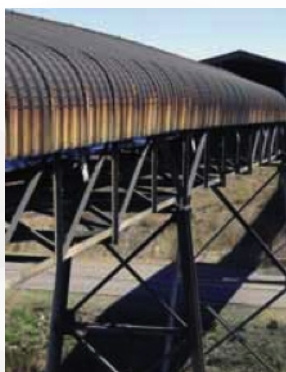
The hot dip galvanized structural steelwork is still performing exceptionally well after 20 years of service.

Inspection after 25 years of service showed the steelwork to be in excellent condition with coating thickness varying between 117 to 279 μ m, with a mean coating thickness of 140 μ m. The coating thickness readings are still well in excess of that required by the specification and suggested an additional 40 to 60 year maintenance-free service life. The only concern was that the conveyor idlers were only painted and the electroplated fasteners were in need of replacement.

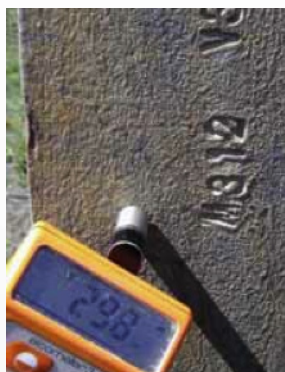
Coating thickness readings taken on the supporting steelwork were still in excess of that required by the specification.

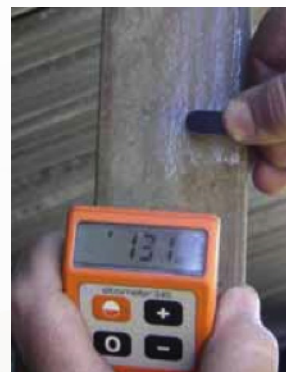
Coating thickness readings taken on the conveyor steelwork were still in excess of that required by the specification.

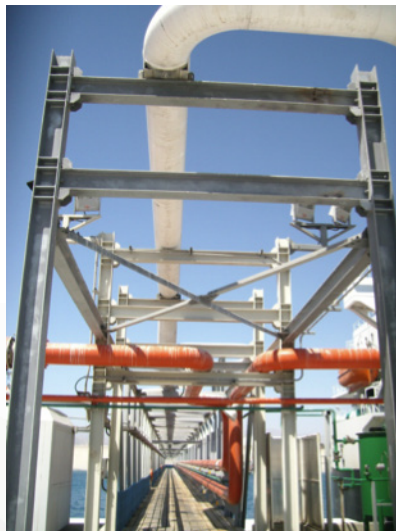
Figure 1. There were some white zinc corrosion products on the surface of these beams, but no steel corrosion was observed.

Galvanized structure under the floor of the access bridge (Fig.1)		Galvanized structure at head of pier (Fig.2)		
Year of thickness measurement	2011	2012	2009	2011	2012
Measured average thickness of coating	208µm	201µm	148µm	144µm	141µm

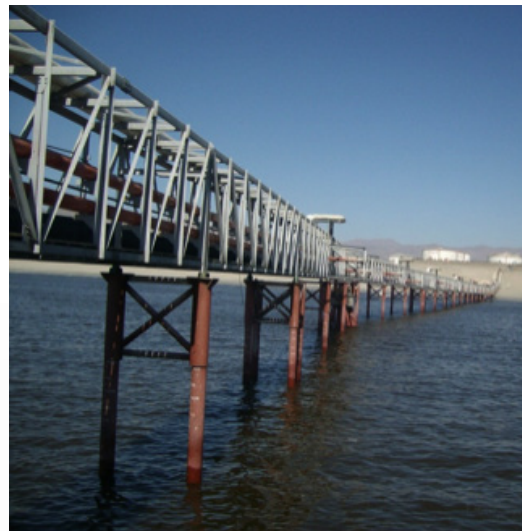
Figure 2. Coating thickness losses were in agreement with the reference range for the CSM climate according to ISO specifications 9223, 14713 and 12944.
