Indian Steel Sheet Building Group: Technical Note 3.3

Corrosion – Mechanisms, Prevention, and TestingRev 0 Jan 2007

Dark-Colored Stains on Galvannealed Sheet

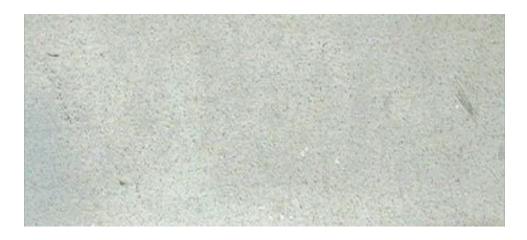
Normally, galvannealed steel sheet has a very uniform matte-grey appearance, as is shown in Figure 1.

Figure 1: Normal appearance of galvannealed steel sheet

The color may be slightly lighter or darker, reflecting a respectively lower or higher percentage of iron in the coating.

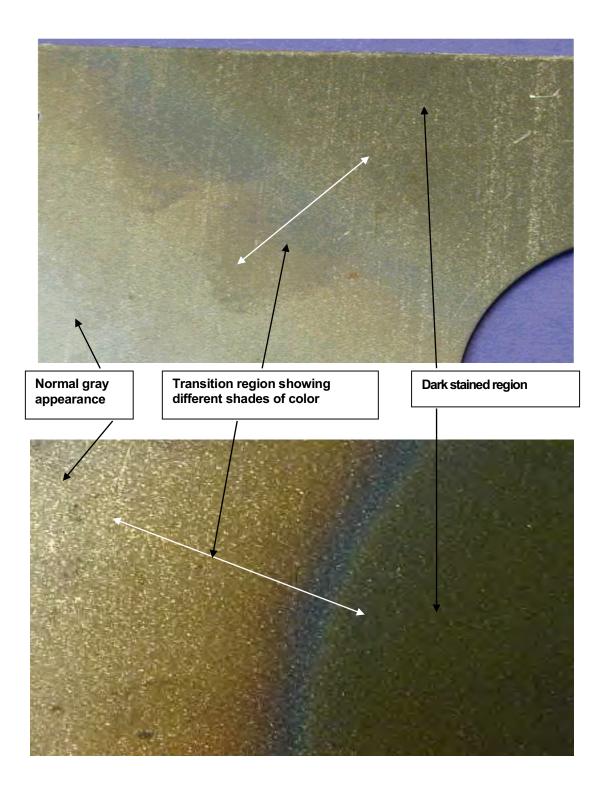
At times, the users of galvannealed sheet complain about localized dark stains on the surface of a galvannealed coating. Often, these stains have a dark grey to black appearance. The dark stained areas usually transition to a lighter grey around their periphery, but at times, there is anything from a straw colored to a dark purple hue around the edges.

Dark areas can range in size from small to large (less than 1 inch to many inches in diameter), be rounded or very irregular in shape, be uniformly dark or exhibit variable darkening, or show a gradation in darkness as they transition to the unaffected areas.

Figure 2 shows two photographs of galvannealed coatings with areas of dark stain and the transitioning to a normal grey appearance.

Figure 2: Dark stains on galvannealed steel sheet

Regardless of the color or shape, there is one primary cause for darkening. This is the **presence of moisture**, either from intrusion during storage and shipping or from condensation within the coil during transit and storage.

For galvannealed sheet product, corrosion of the coating also occurs if the coil or bundle of sheets gets wet and has no way of drying. Instead of forming white rust, the first appearance change is the formation of an adherent oxide that is most often dark grey to black in color. The iron in the coating is the main reason for nature of this corrosion product – the result of localized galvanic coupling on the Zn-Fe surface alloy layer. The stain does not form as a loose powder, but is a thin, often adherent continuous film. Its dark grey to black color is associated with the light absorbing characteristics of the thin film of corrosion product. If the sheet stays wet for long periods and large amounts of corrosion product form, the stain may begin to exhibit the same flocculent white corrosion product that is observed on storage-stained galvanized sheet.

1. As the susceptibility of galvannealed sheet to exhibit dark grey to black surface discoloration is caused by the intrusion of water during shipping or storage, or condensation of moisture onto the sheet surfaces, it is extremely important to keep the product dry. For example, when a coil stored at 70°F in a warehouse is shipped to a customer during the wintertime, there is a high potential for condensation to occur within the coil. If, at the customer's site, the coil is then allowed to sit for a period of time before

- 2. Consider ordering the product "oiled", and then utilize good cleaning practices that employ staged alkaline cleaning. The presence of rust-inhibitive oil will dramatically extend the shelf life of galvannealed sheet, and help prevent storage staining.

- 3. In some instances, cooperative work amongst the steel producer, surface treatment supplier, and paint company has allowed the customer to paint over the surface passivation film applied at the exit end of the hot-dip coating line. If passivated galvanneal can be successfully painted, then the probability of dark storage stains developing is dramatically reduced.

- 4. If dark stains are present on a galvannealed sheet, it does not necessarily mean that paint adhesion will be "poor" for all applications. Typically, the dark stain corrosion product that is formed is a thin adherent film on the surface of the galvannealed coating. Paint trials are recommended to determine if the dark stain does indeed adversely affect paint adhesion. If not, it may then be possible to use the stained galvannealed product.
