Indian Steel Sheet Building Group: Technical Note 6.1

Using Metallic-Coated Steel Sheet

Successfully Shipping and Storing Galvanized Steel Sheet

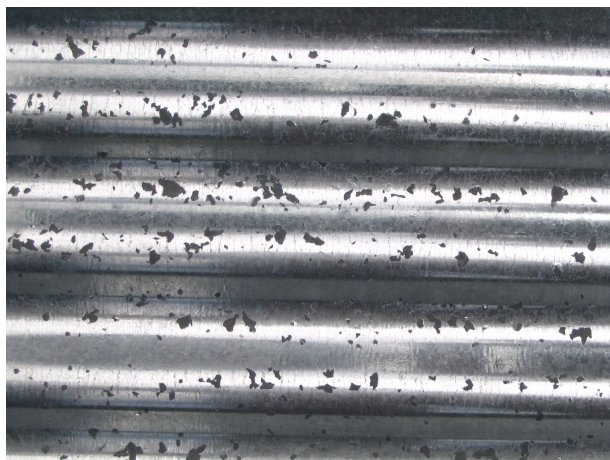
On corrugated sheet

Fretting Corrosion Marks

Galvanized sheet surfaces sometimes exhibit a surface imperfection that appears as permanent black spots, marks, lines, or patches. This defect has many names, including transit abrasion, friction oxidation, wear oxidation, and chafing; all being terms for a form of erosion-corrosion known as fretting. It is a

For many years fretting problems have been observed on galvanized steel in both coil form and bundles of cut sheets. The defect is never seen at the production line and when found is almost always at customer facilities. It tends to be more prevalent on coil form and on material thicker than 0.030 in [0.8 mm]. Without fail, it is also characterized by a lower intensity mirror image on the reverse side of the sheet.

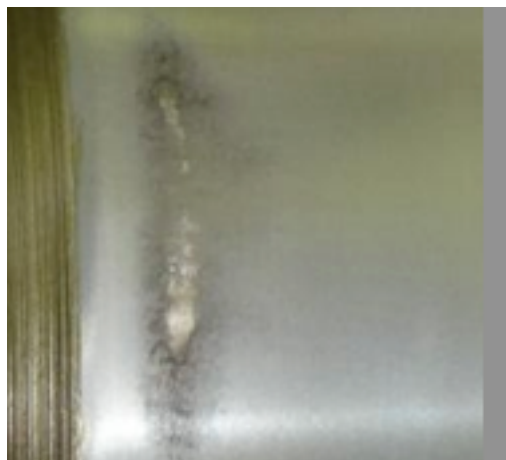
At the load-bearing point on coiled sheet

All of the above measures are not practical in the case of galvanized sheet, but investigations at one steel supplier have indicated that some are effective to varying degrees. An action that has met with some success is redesigning support saddles to reduce concentrated point loading on the bottom of coils. By distributing the weight of the coil over the entire area of the saddle(s), there is less pressure at any one point, resulting in less transit damage given that vibration will always be present. A slightly less effective way of accomplishing the same result is to reduce the coil size, but this is perhaps not a desirable option
